Windstorm Mitigation Report

Caribbean Cove

Largo, FL

As of 02-19-2025 | FPAT File# MIT2524263

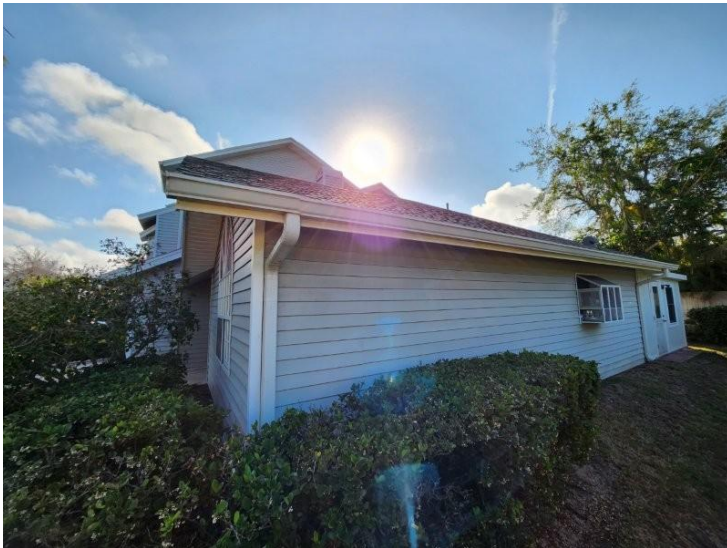
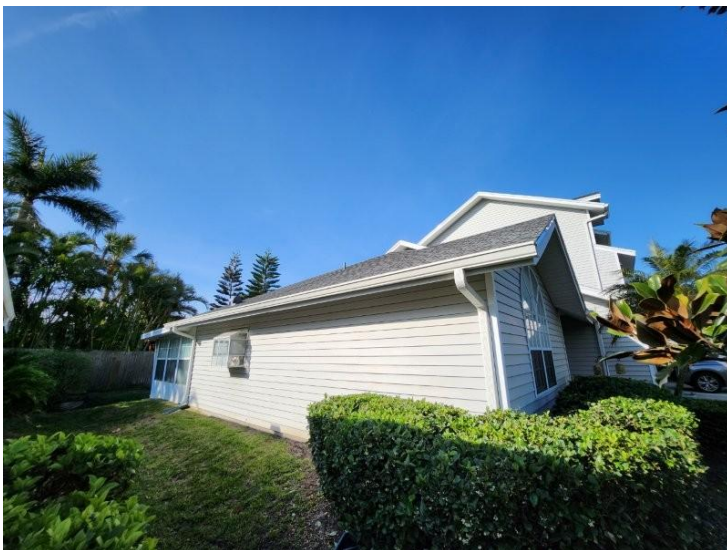
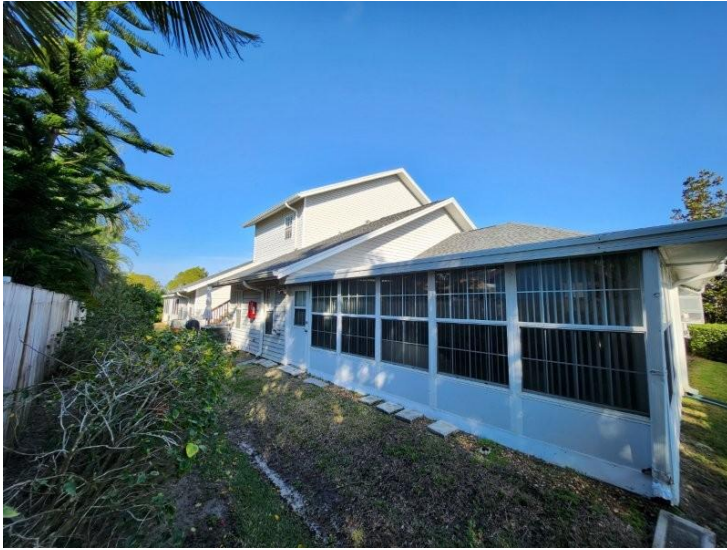
Exterior Elevation

- 6. SWR:** **No**
Comments: At the time of inspection, no SWR was verified.
- 7. Opening Protection:** **None or Some Glazed Openings**
Comments: No opening protection verified at the time of inspection.

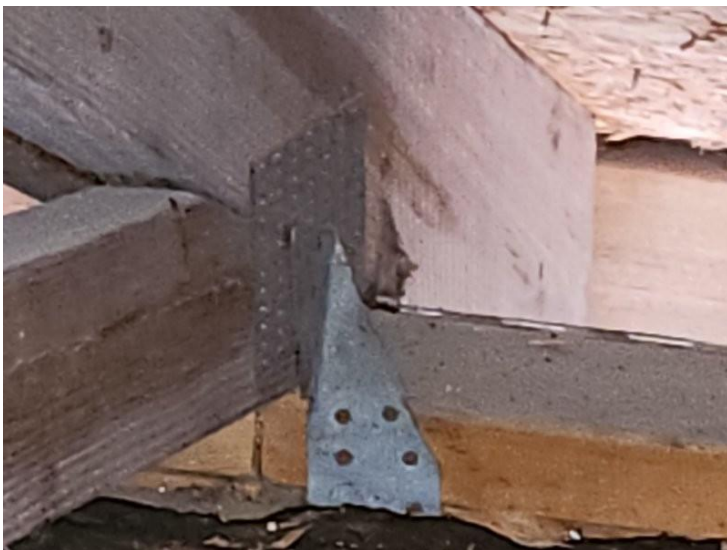
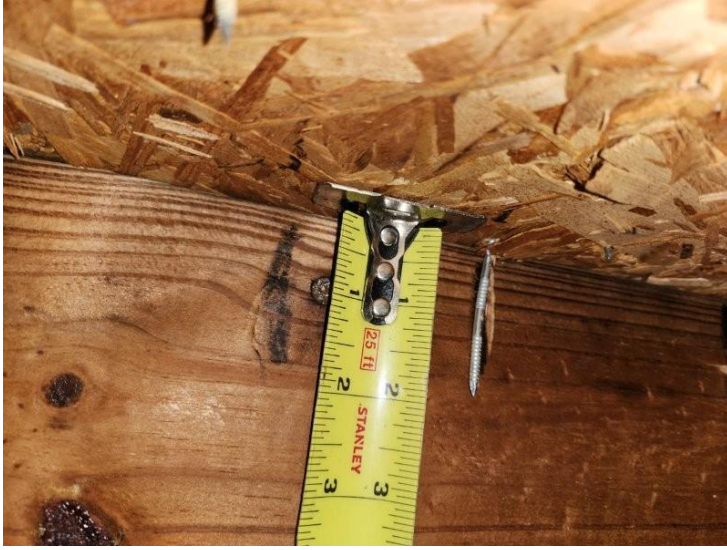
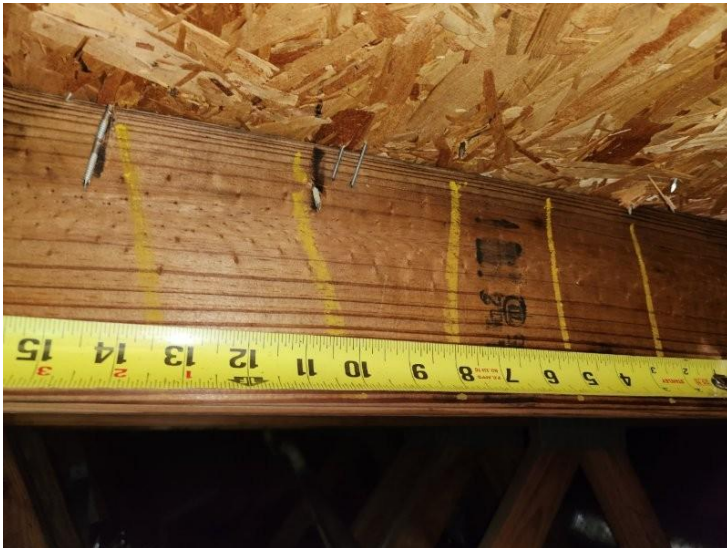
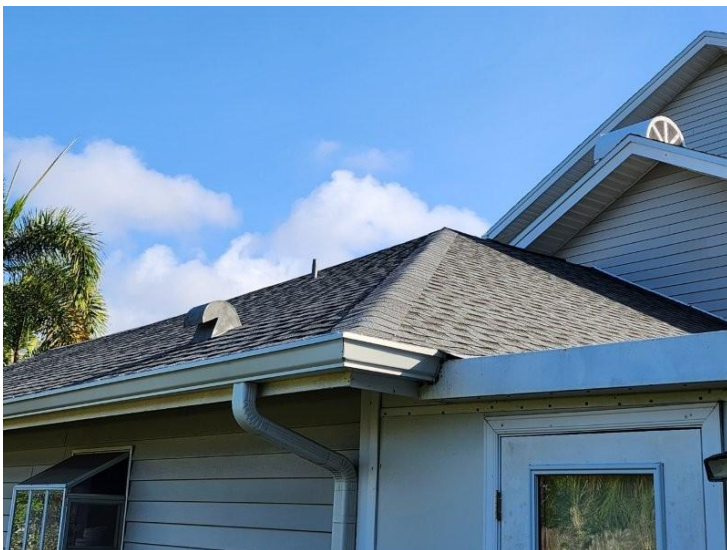
Roof Construction

- 3. Roof Deck Attachment:** **Level C**
Comments: Inspection verified 7/16" OSB roof deck attached with 8d nails at a minimum 6" on the edge & 6" in the field.

- 4. Roof to Wall Attachment:** **Clips**
Comments: Inspection verified hurricane clips fastened with a minimum of three nails.
- 5. Roof Geometry:** **Other Roof**
Comments: Inspection verified hip and gable roof shapes. The gable sections of the roof account for greater than 49% of the total roof perimeter.

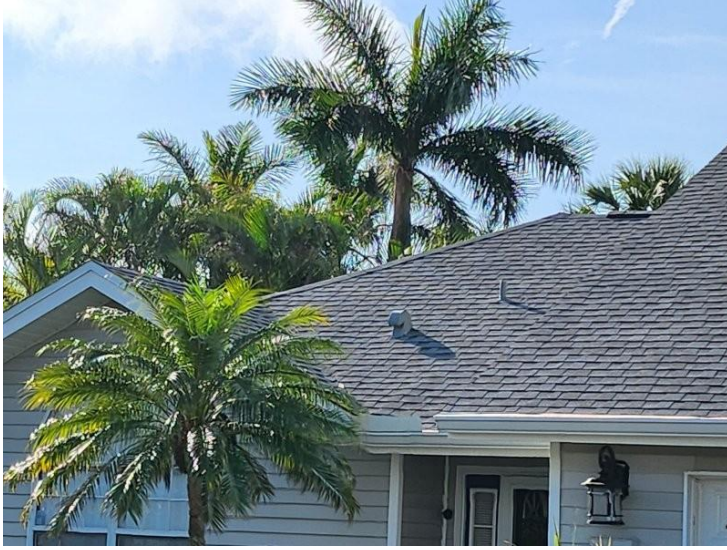
Roof Construction

- 2. Roof Covering:** **FBC Equivalent**
Comments: The roof covering was replaced in 2025. The roof permit was confirmed and the permit number is ROOF-24-000846. This roof was verified as meeting the building code requirements outlined on the mitigation affidavit.

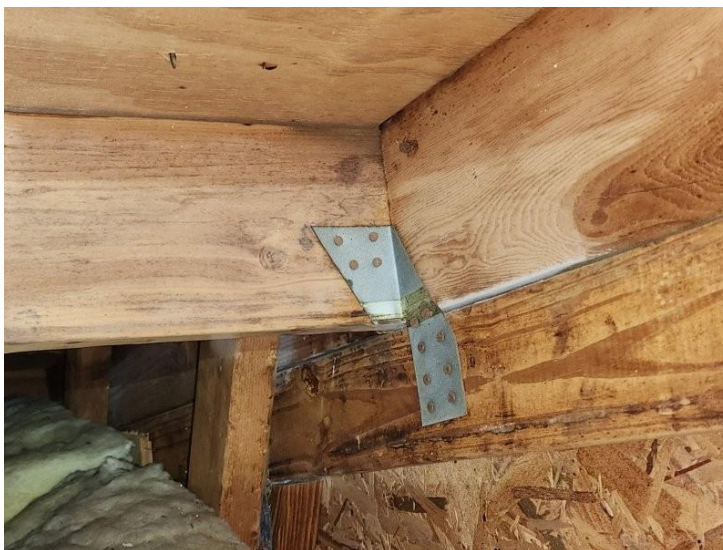
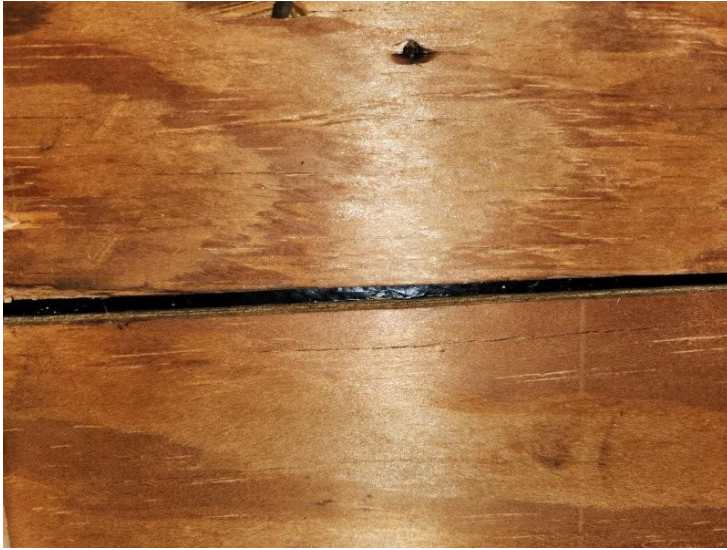
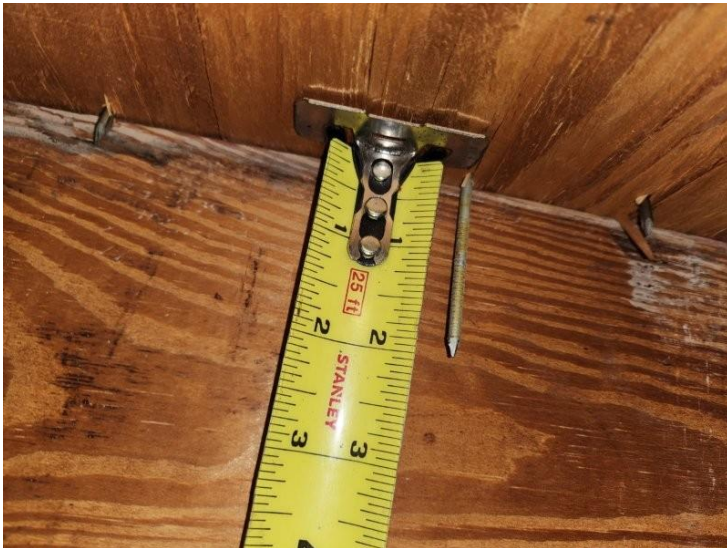
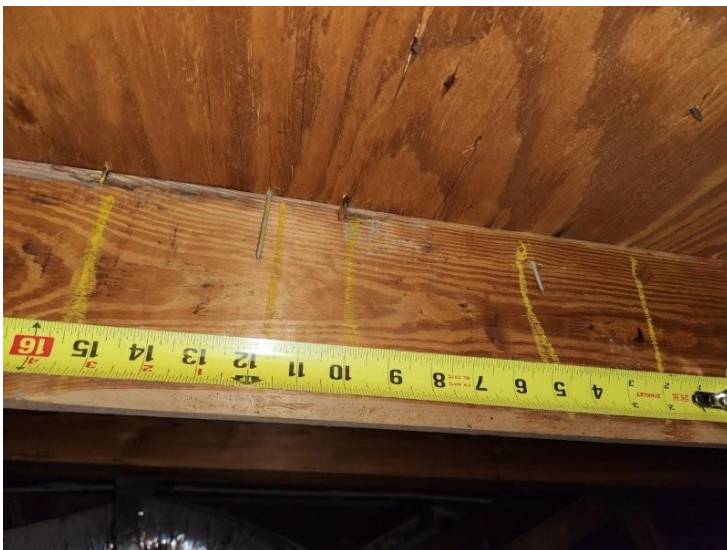
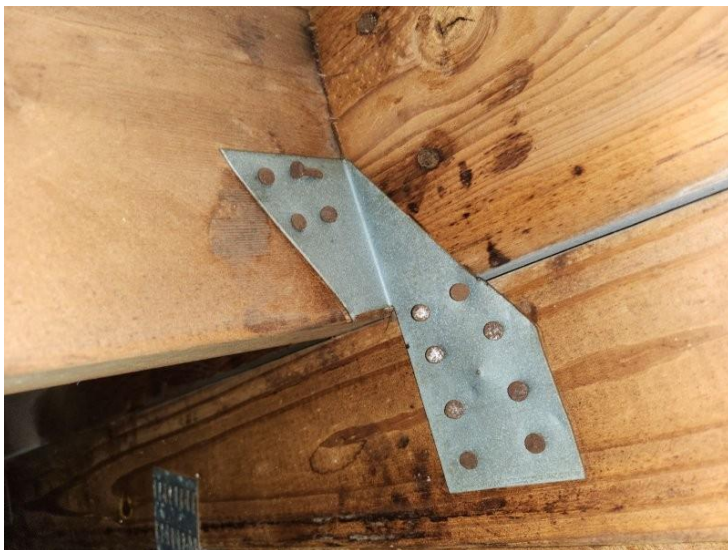
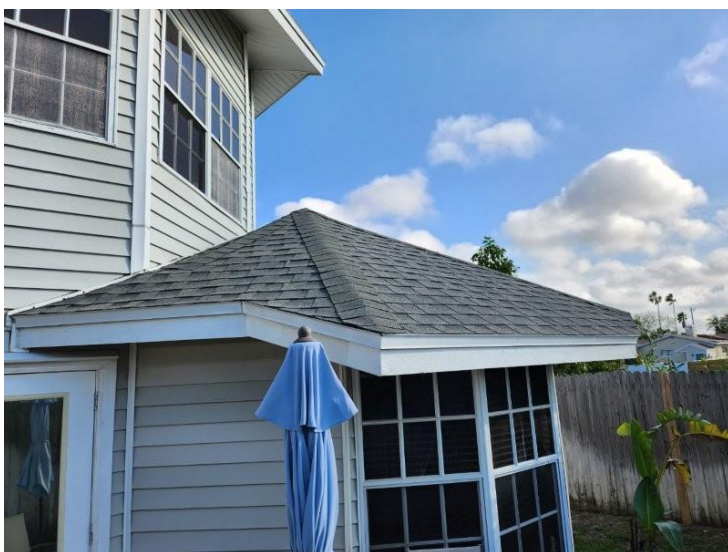
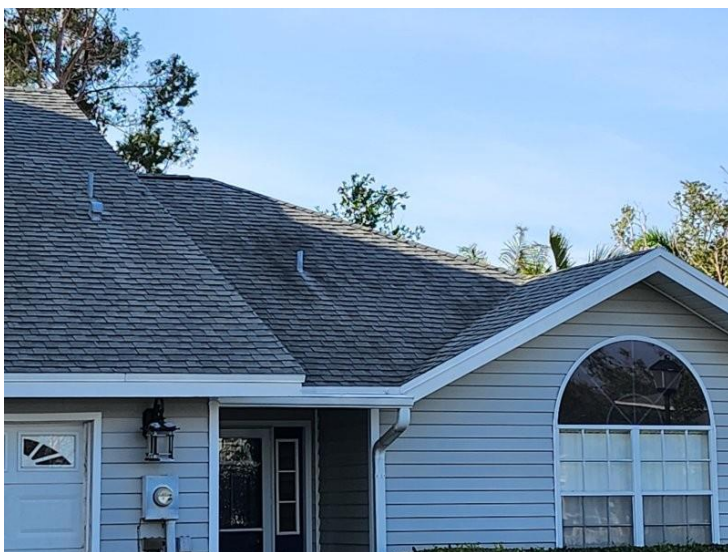
Roof Construction

- 3. Roof Deck Attachment:** **Level C**
Comments: Inspection verified 1/2" plywood roof deck attached with 8d nails at a minimum 6" on the edge & 6" in the field.

- 4. Roof to Wall Attachment:** **Clips**
Comments: Inspection verified hurricane clips fastened with a minimum of three nails.
- 5. Roof Geometry:** **Other Roof**
Comments: Inspection verified hip and gable roof shapes. The gable sections of the roof account for greater than 49% of the total roof perimeter.

- 6. SWR:** **Yes**
Comments: SWR was verified at time of inspection. The Secondary Water Resistance verified is a self-adhering peel and stick.
- 7. Opening Protection:** **None or Some Glazed Openings**
Comments: No opening protection verified at the time of inspection.
